**HISTORICAL DEVELOPMENT
AND QUALITY OF THE
TORONTO WATERFRONT SEDIMENTS -
PART 1**

MAY, 1985

Prepared by:
D. Persaud, T. Lomas, D. Boyd and S. Mathai
Great Lakes Section
Water Resources Branch
Ministry of the Environment

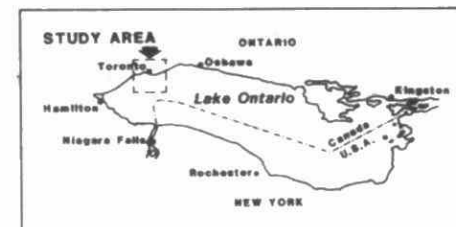
FIGURE 2.1
STUDY AREA

The study area is located on the northwestern shore of Lake Ontario and covers the nearshore area of Toronto bounded by Highland Creek in the east; Etobicoke Creek in the west; the shoreline of the Toronto area (Toronto Harbour included) and roughly the 20 meter(m) depth contour on the lakeward side. See Figure 2.1 for the study area.

The two stations that were sampled in the Humber Bay lakefill embayment (2113, 2117, Figure 2.1) had elevated levels of the parameters measured. The sediments at Station 2117 in the eastern embayment were highly contaminated. This is not unexpected since this embayment likely traps material from the Humber River discharges and Humber Bay Sewage Treatment Plant discharge.
